Fast Facts

Validation of Aurora Solar's Remote Measurement Capabilities

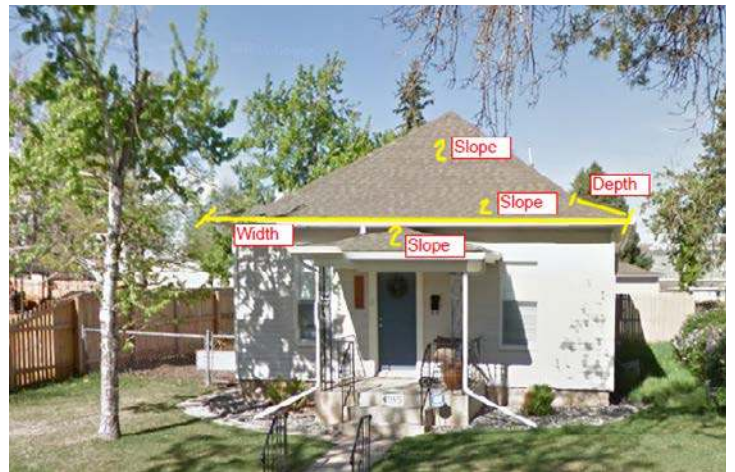
Figure 2: Roof that resulted in inaccurate measurement

Of all measurements collected and compared to Aurora’s calculations, only one was noncompliant. The roof in which the maximum slope difference was

7.33 degrees, exceeding the 5-degree stated limit, was built in 1908 and had a measured main roof slope of 36.2 degrees. Aurora’s software calculated the roof slope to be 43.53 degrees. The Aurora team evaluated this discrepancy and pinpointed the source of the error as poor site visibility from Google Street View.
